# ENGINEERING REPORT

## EVALUATION OF PLANDOME PARK POND

Plandome Heights  
Nassau County, New York

H2M Project No.  
TONH 13-02

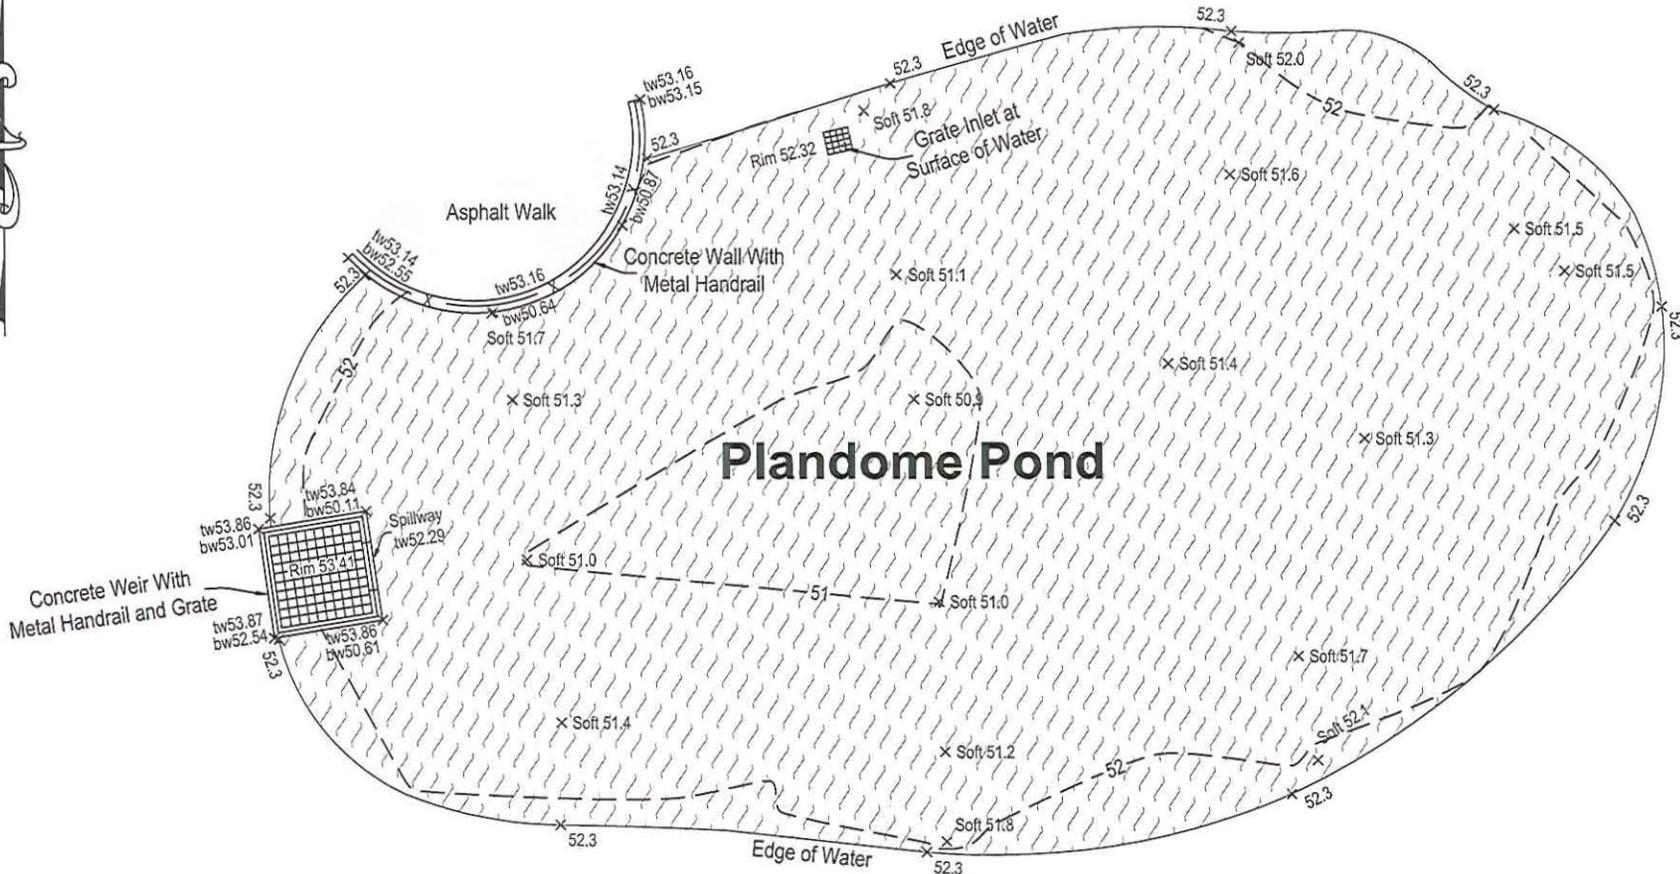
**FIGURE 2a**

H2M assigned a field survey team to perform a topographic survey of Plandome Pond. This survey included the elevations of the organic sediment (soft bottom) as well as the elevations of the underlying sand (hard bottom). The hard bottom sand provides a more natural pond surface. Copies of these surveys are included in Figures 2a and 2b. Based on the results of these surveys, we calculated a total of approximately 500 cubic yards of accumulated organic sediment that could be dredged from Plandome Pond.

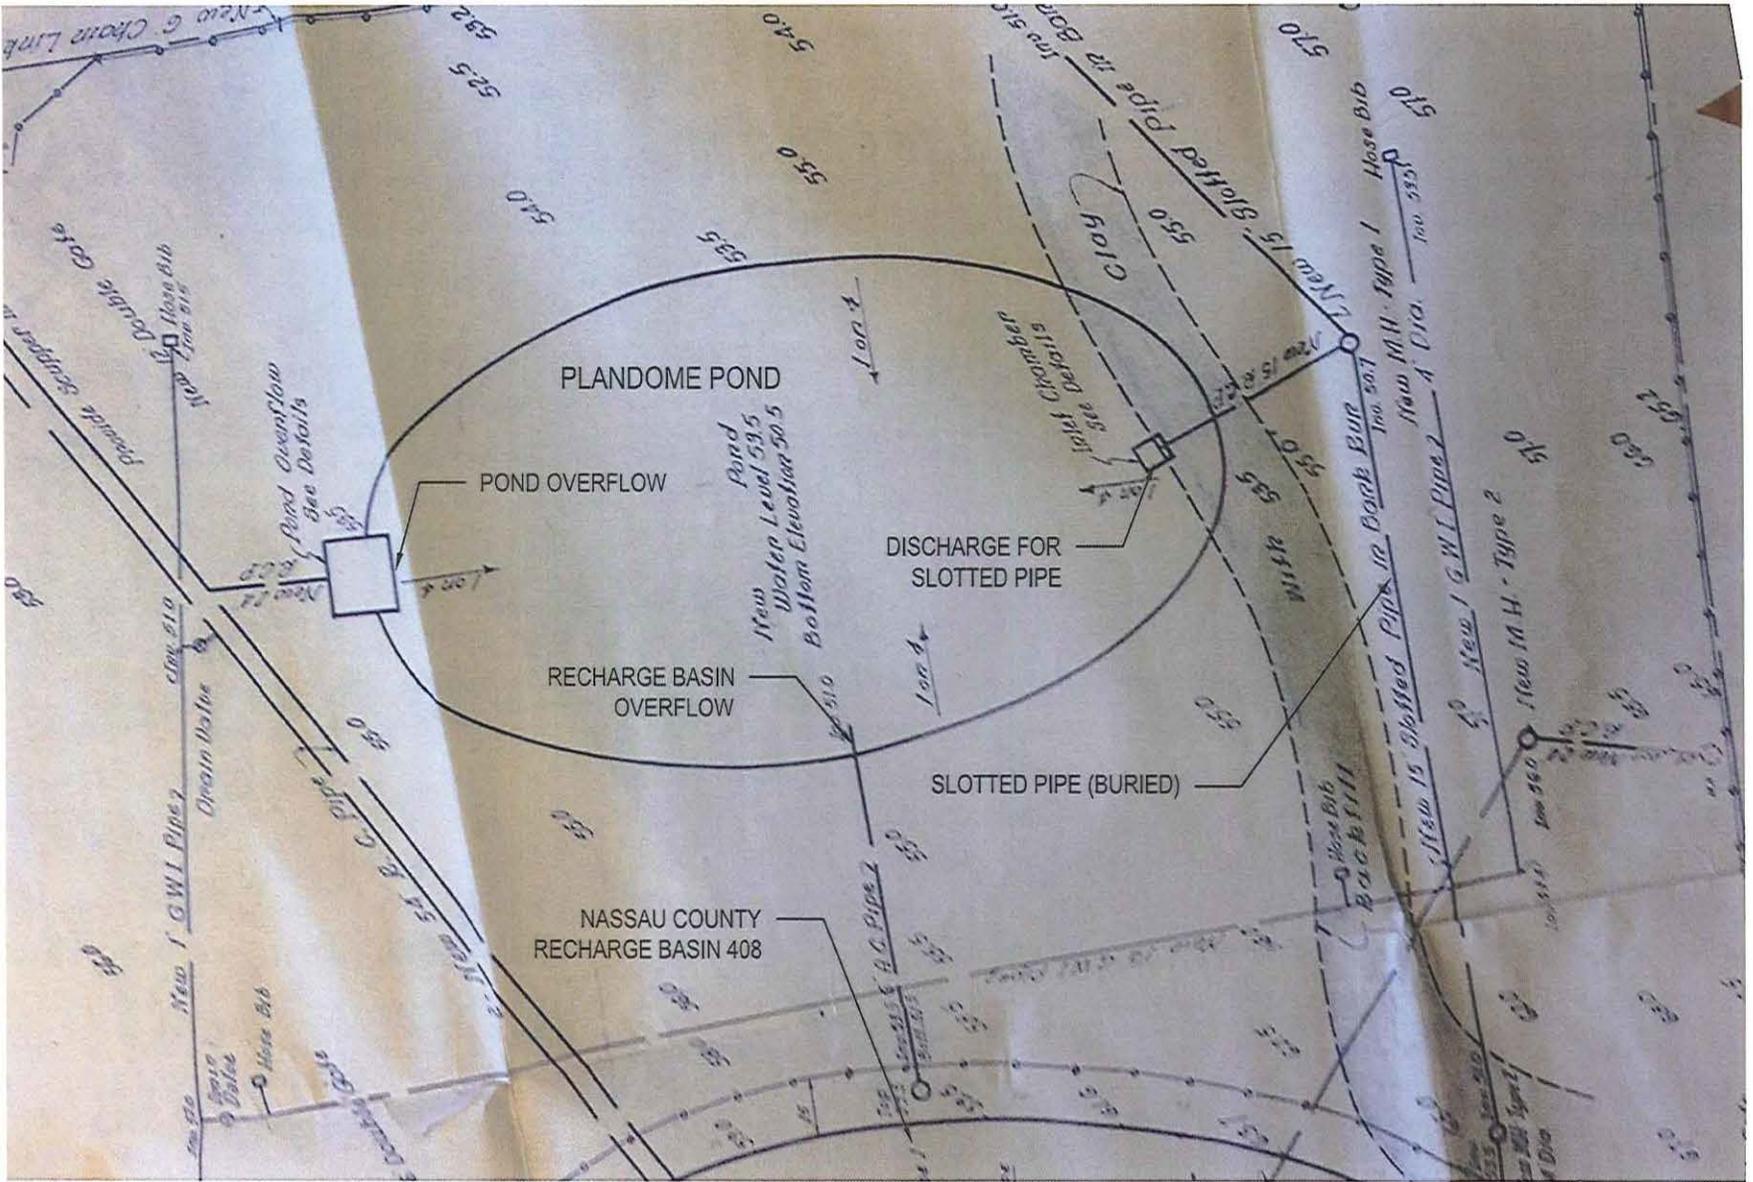
**FIGURE 3**

Organic sediment is typically introduced by storm water runoff. A review of record plans provided by Nassau County Department of Public Works identified two piped discharges into the pond. The first is a 6 inch diameter overflow pipe from Nassau County Recharge Basin No. 408 located at the south side of the pond. The other is a 15" diameter pipe that appears to discharge water from a series of buried slotted pipes on the east side of the pond. No visible evidence of either of these pipes was located in the field, as they are likely buried. However, during a rain event, we did note a slight turbulence in the water in the apparent vicinity of the 15" pipe, which would suggest the pipe is present and discharging storm water runoff into the pond. Additional runoff is also introduced via overland flow from the landscaped lawn area surrounding the pond. A copy of the record plan sheet that identifies these outfalls is included as Figure 3.

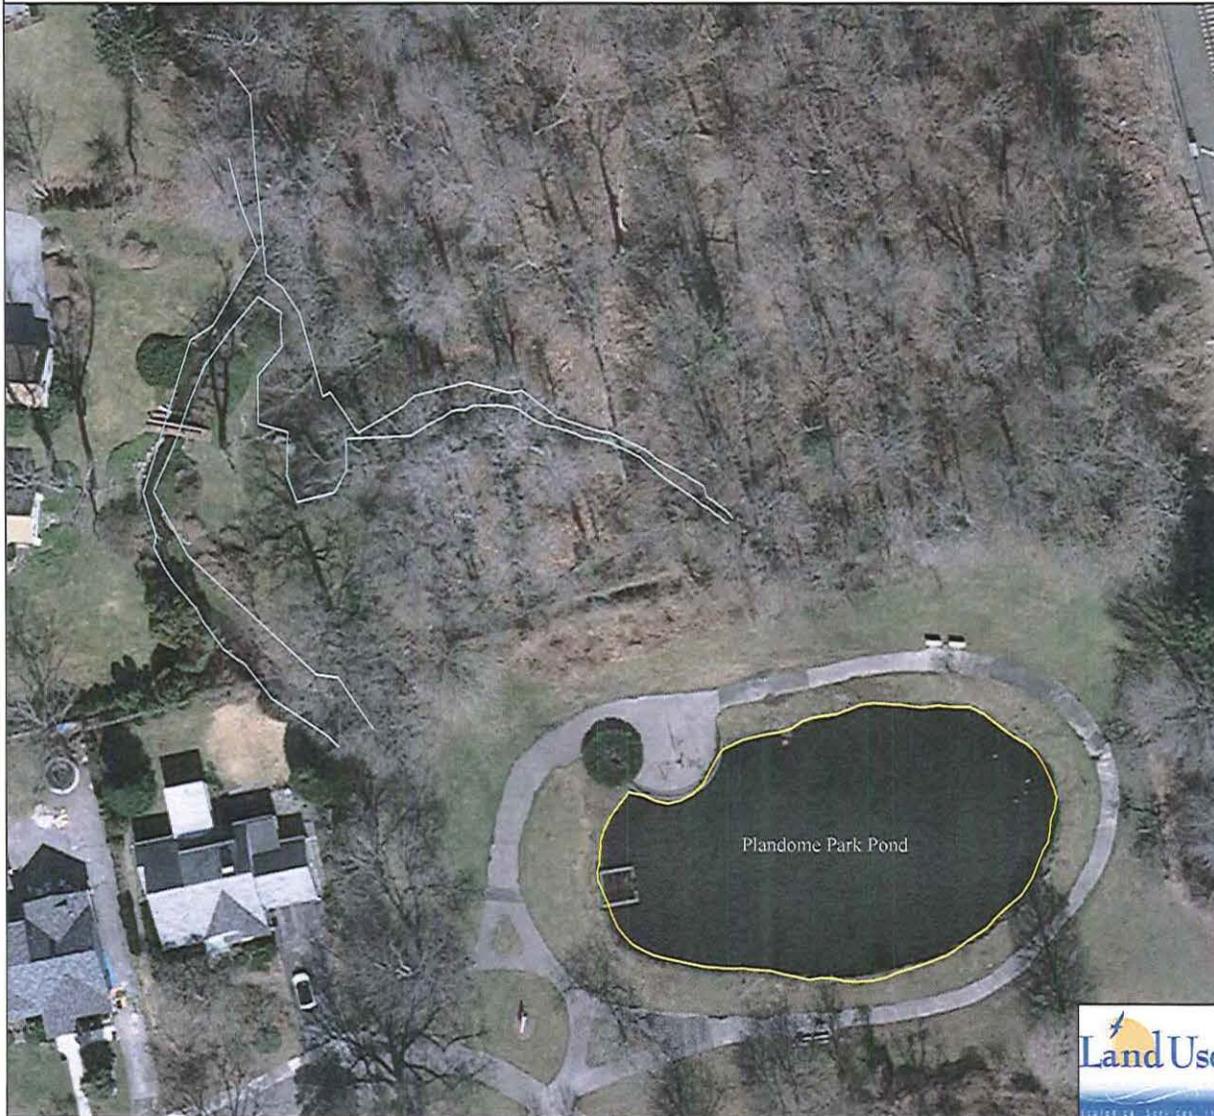
Sheet: Figure 4

Plandome Park Pond Study - Environmental Conditions

1. Freshwater wetland boundary equivalent to Plandome Park Pond Shoreline and Stream -Top of Bank as determined by W.P. Bowman, PhD, Land Use Ecological Services, Inc. on 10/15/2013.
2. Environmental data collected 10/15/2013 by Land Use Ecological Services, Inc. using hand-held GPS unit with sub-meter accuracy.
3. 2010 orthoimage from NYS ITS (<http://gis.ny.gov>)

Plandome Pond is not a regulated freshwater wetland under New York State's Freshwater Wetlands Act (Article 24). Leeds Pond is a regulated freshwater wetland, as are the hardwood swamps adjacent to the streams that discharge into the south end of Leeds Pond. However, no freshwater wetland communities were located adjacent to the stream located within 300 feet of Plandome Park. Thus, dredging of Plandome Pond would not require the Freshwater Wetlands permit from the NYSDEC that is necessary for most dredging projects on Long Island. However, dredging at Plandome Pond would be regulated under the NYSDEC's Protection of Waters (Article 15) regulations. Article 15 restricts excavation/dredging in navigable waters and wetlands "adjacent or contiguous to" navigable waters. The NYSDEC interprets "adjacent or contiguous to" very broadly and, as a result, Plandome Pond is regulated under Article 15 due to its hydrological connection to Manhasset Bay and Leeds Pond through the freshwater stream to the east of Brookside Drive.
